Evaluating the Walkability of Traditional Main Streets: A Comparative Analysis of downtown
Brockville, Cornwall and Kingston, Ontario.

A report submitted to the School of Urban and Regional Planning in conformity with the
requirements for the degree of Master of Urban and Regional Planning

Queen's University
Kingston, Ontario
September 2015

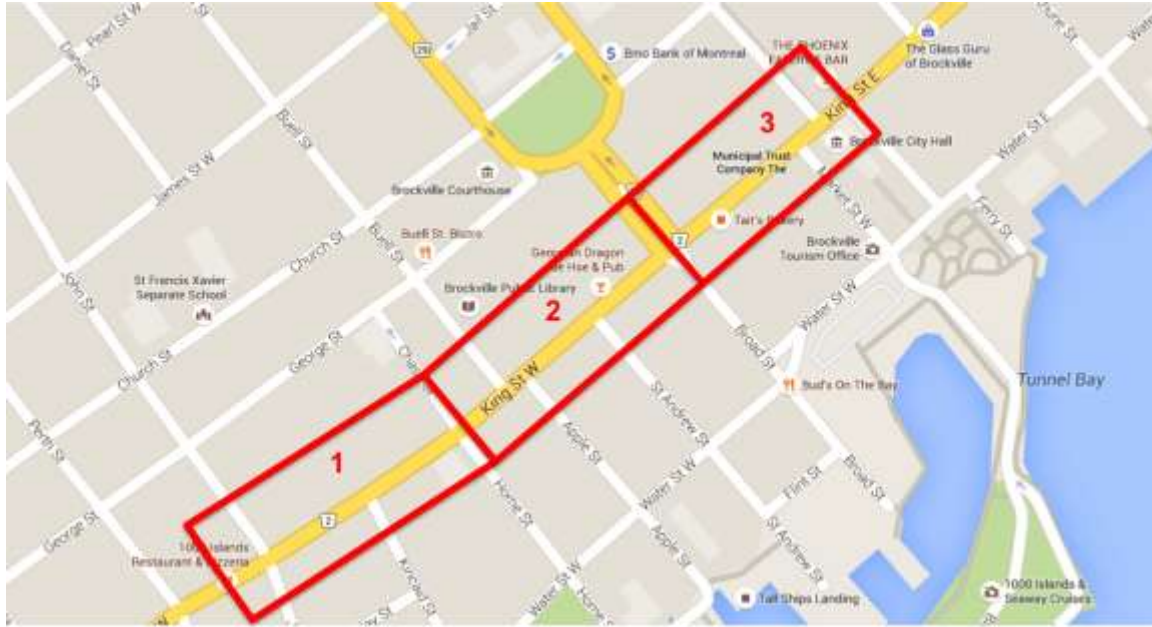
Figure 5: King Street, Brockville, ON.

King Street is an arterial street that runs parallel to the St. Lawrence River through the centre of Brockville's downtown, parallel to the St. Lawrence River. The street is, in fact, an urban segment of King's Highway Number 2, commonly referred to as Highway 2. Although King Street is downtown Brockville's main commercial strip, there has been a significant economic decline in the area over the last several years and many storefronts now lie empty and abandoned (City of Brockville, 2013). In December of 2009, the City of Brockville adopted the Downtown & Waterfront Master Plan & Urban Design Strategy and it is from this document that the boundaries of the CBD are drawn. The King Street study segments are illustrated in Figure 5.

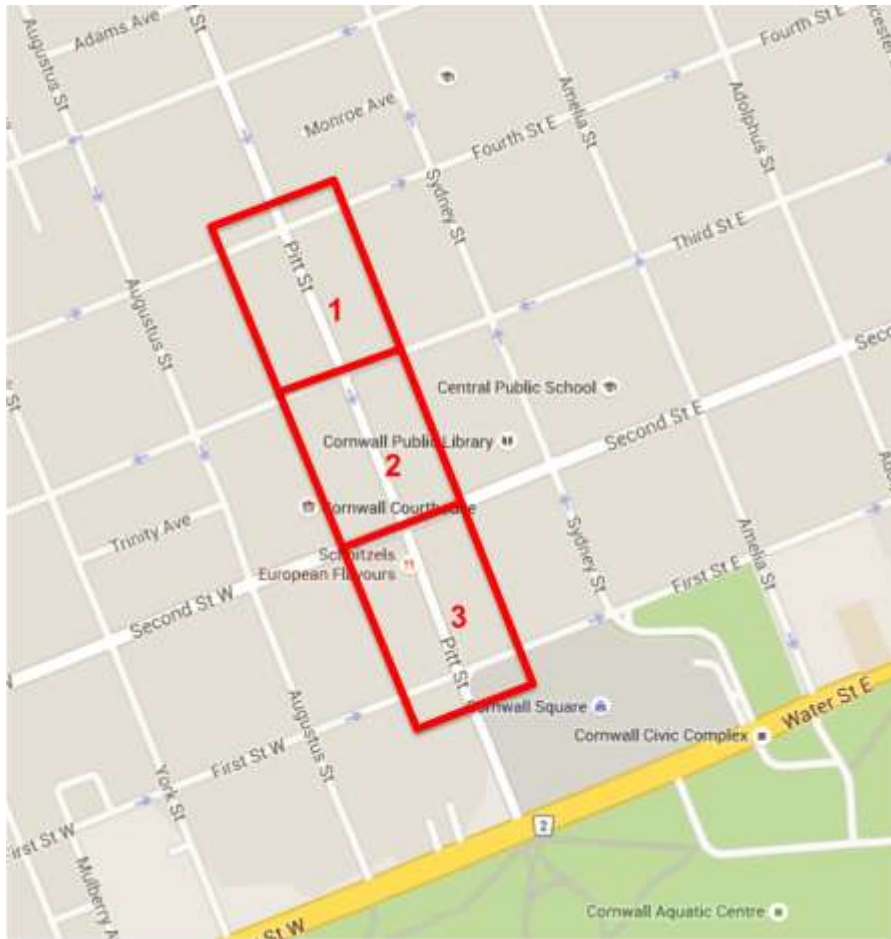
Figure 6: Pitt Street study area, Cornwall, ON.

Pitt Street is a one-way arterial road at the heart of Cornwall’s original Central Business District. However, the last three decades have seen commercial development occur primarily in areas outside of the downtown and thus commercial enterprises along Pitt Street have suffered (Heart of the City, 2004). In 2003, Toronto-based consulting firm Forrec published a revitalization plan for Pitt Street that included recommendations for streetscape upgrades such as the relocation of electrical wires, instruction of new landscaping features and the replacement of current mix-matched lighting (Forrec, 2003). In 2005, IBI Group published a follow-up document outlining implementation strategies for the Forrec designs in a Community Improvement Plan. Unfortunately, very few of these upgrades have been executed. The Pitt Street study segments are illustrated in Figure 6.

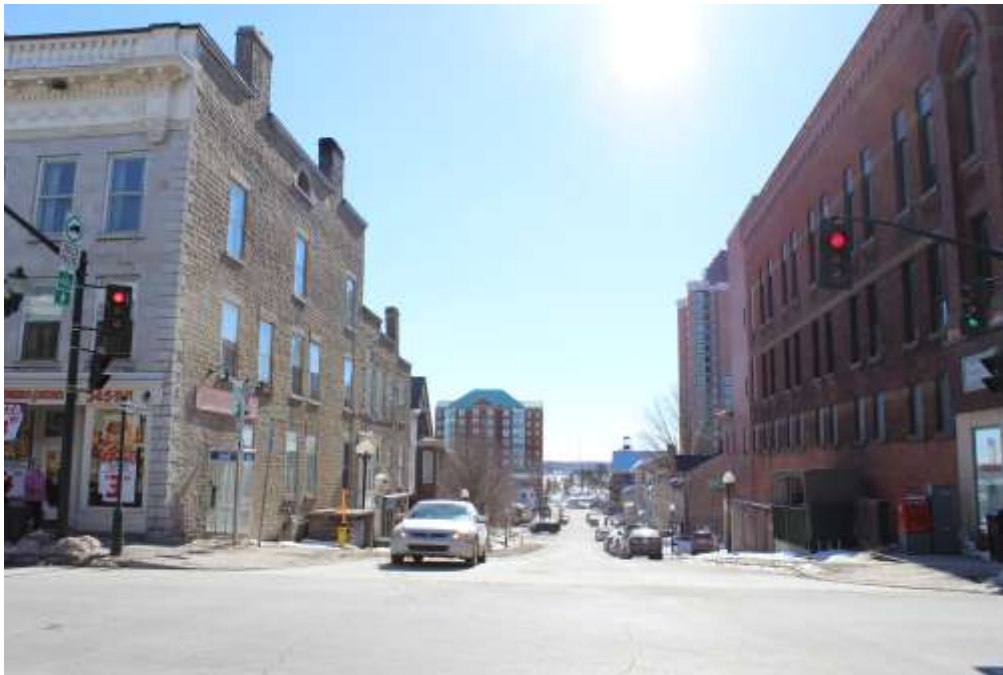
Figure 8: Southern views at an intersection along King Street look toward the St. Lawrence River and Brockville Yacht Club.

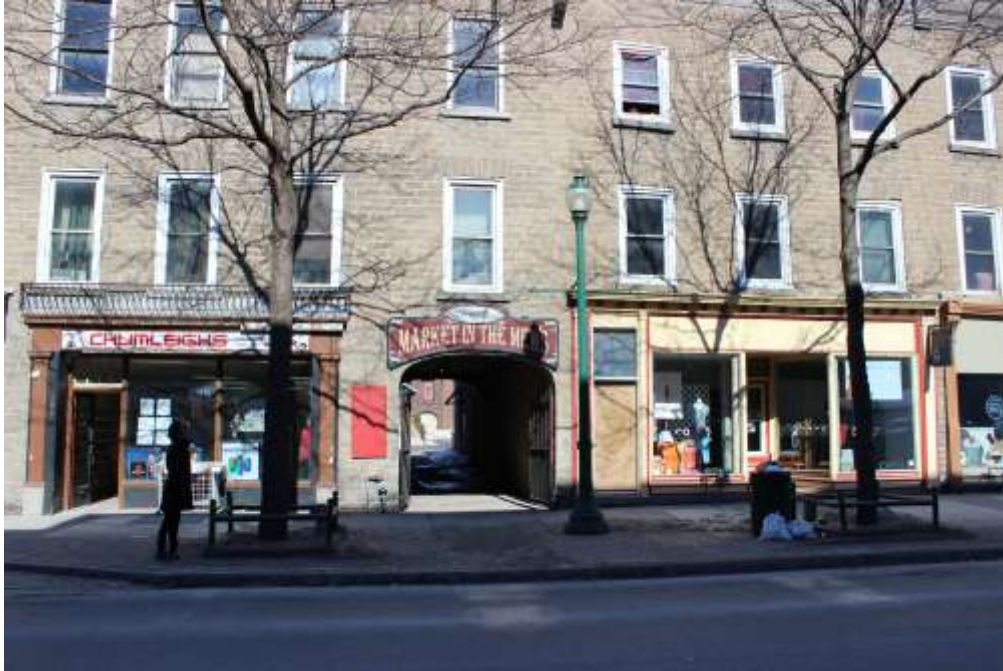
Figure 9: Historic carriageway along King Street provides access to rear courtyard.

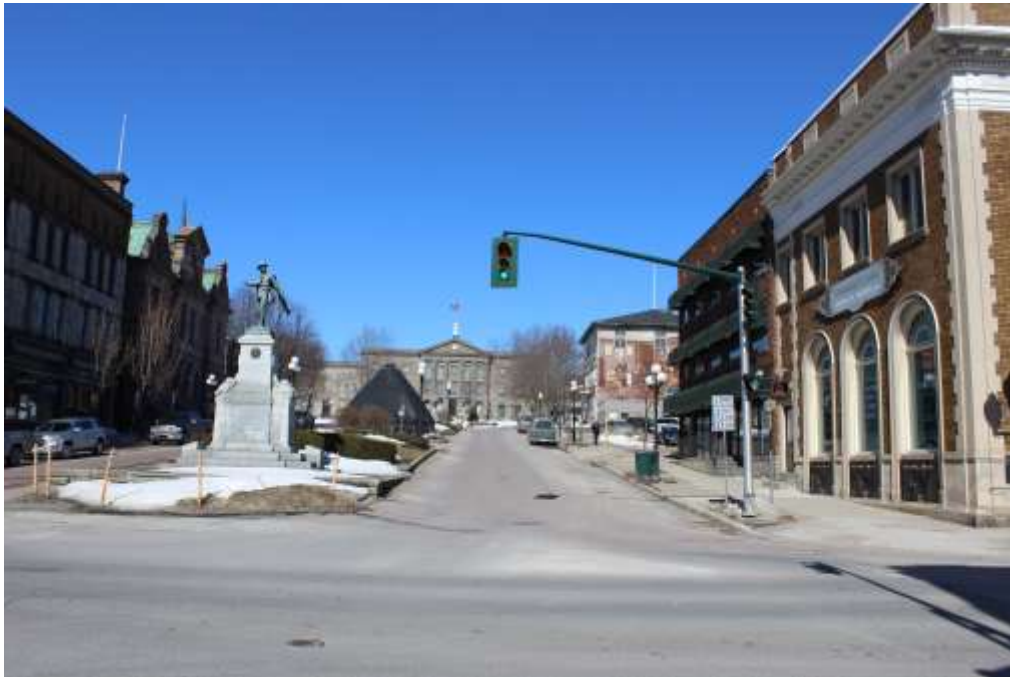
studied corridor (Figure 10). The consistent use of themed lighting, seating and other street furniture also contributed to the street’s identity. Views to the North at the intersection of Broad Street are directed up a well-manicured boulevard containing a historic fountain to the city’s architecturally significant courthouse (Figure 9). Furthermore, due to the low-rise nature of many of the buildings, as well as the various cross-streets running toward the waterfront, there are numerous unobstructed views toward the St. Lawrence River to the South (Figure 8). These key landmarks are integral to Brockville’s well-preserved downtown core. Pedestrian activity was high along the street and noise levels kept at a relative minimum thanks to strategically placed street trees and planters that create a buffer between the pedestrian clearway and the street.

Figure 10: View North at the intersection of King Street and Broad Street terminated by historic courthouse building. Public art is visible along manicured boulevard.

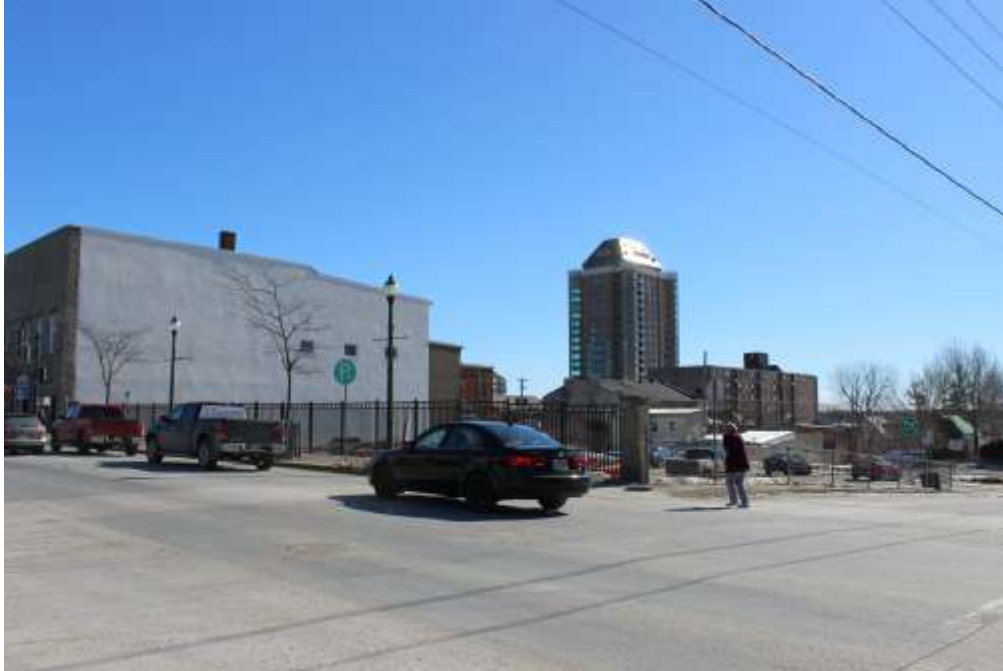
Figure 16: Empty corner lot on King Street in Brockville, ON.

Infilling vacant lots, especially those in prominent locations such as intersection corners, would greatly increase the sense of enclosure along the streetscape. Brockville's underutilized corner parking lots along King Street could be relocated to the rear of buildings or along side streets, creating opportunity to build appropriately-scale, mixed-use structures along the corridor. On the other hand, the most prominent lot vacancy in Cornwall, located at the corner of Pitt Street and Second Street, is directly across the street from the city's tallest building (Figure 35). Not only does the vacancy degrade enclosure, the juxtaposition of the two polar opposites is in violation of the proportions of human scale. Fortunately, the vacant lot currently slotted for 4-storey mixed-use development in the near future, which will greatly enhance enclosure in the area (Figure 36).

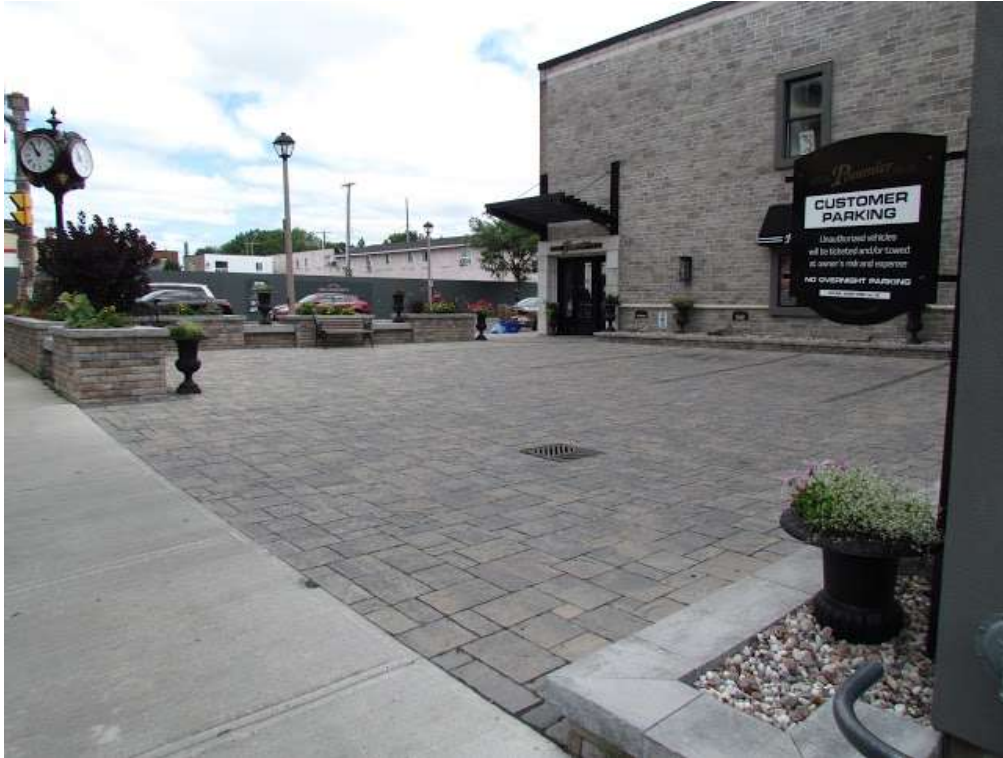
Enclosure scores for Cornwall's Pitt Street were not as impressive as those for Brockville. Although long sight lines provided clear views of the historic clocktower and the waterfront beyond, there were a significant number of vacant lots that created a very broken street wall along the entire corridor. The large vacant lot at the corner of Pitt Street and Second Street is directly across from a large corner parking lot (Figure 17), creating a significant open space along the street frontage. Although the parking lot has been enhanced with aesthetically pleasing pavers and planters, the opposing 8-storey Seaway Building dwarfs it. Pitt Street did score well in terms of the presence, strategic location and frequency of mature street trees along the corridor (Figure 18), however the style of planters and grates in which the trees were planted were not as esthetically pleasing as Brockville's.

Figure 17: A corner parking lot at the corner of Pitt Street and Second Street in Cornwall has been enhanced with quality paving materials and planters, however, it is not appropriate for such a busy intersection.

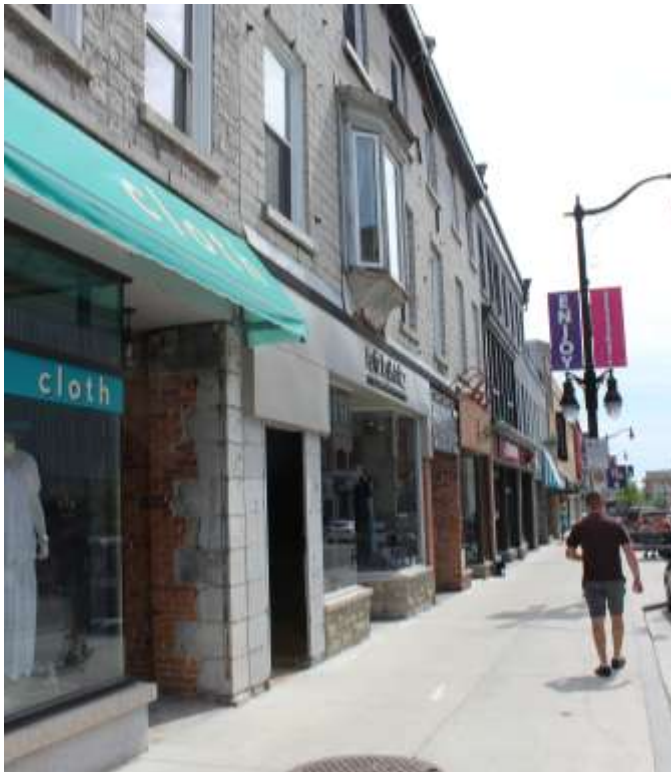
Figure 19: The consistent building wall along Princess Street with building height proportionate to road ROW evokes a sense of place for pedestrians using the space.

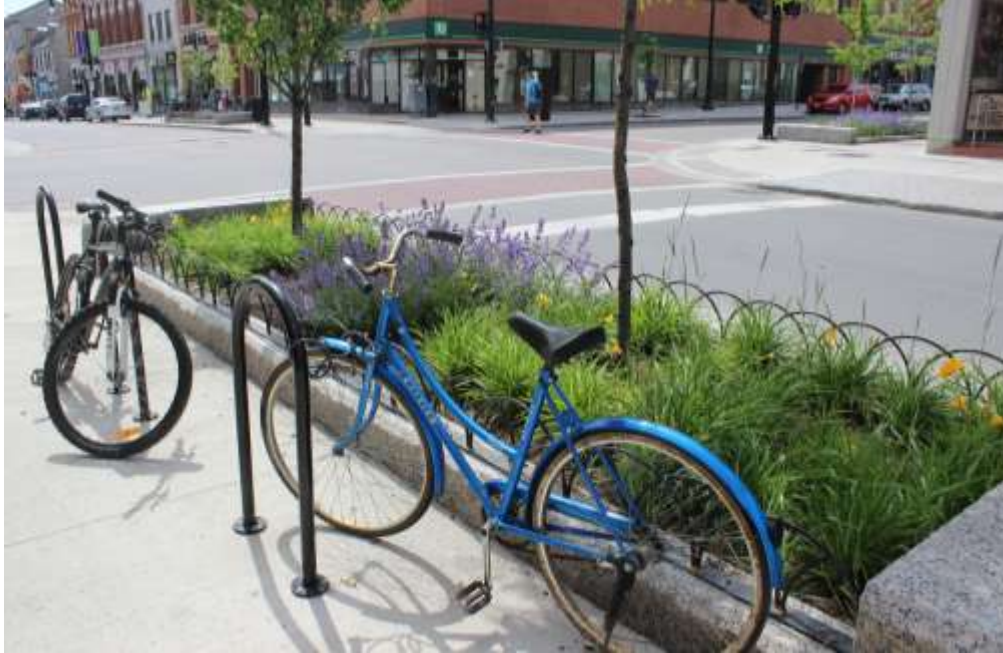
Figure 20: Esthetically pleasing planters not only provide shade and protection from vehicular traffic, they also help to manage stormwater runoff and provide informal seating for users.

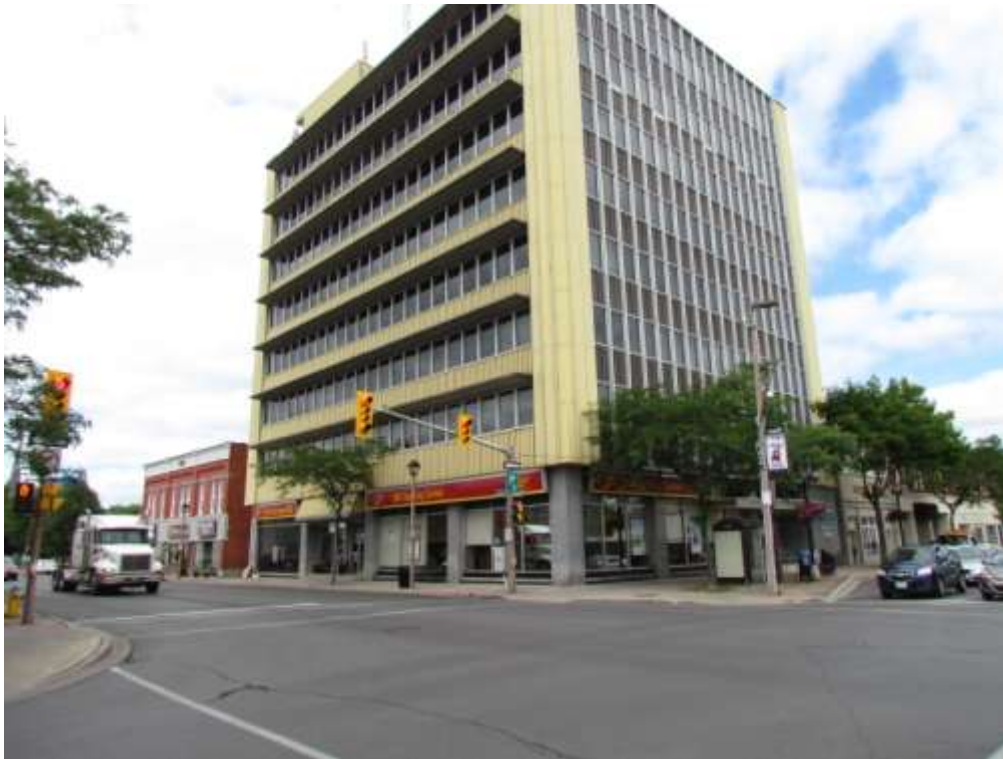
Cornwall's median building height was the lowest of all three case studies with a number of single storey buildings along the corridor. Paradoxically, the street also boasted the tallest building of all three cases: the 8-storey modernist Seaway Building (Figure 23). Many buildings did not have street-facing display windows and many of those that did were vacant and boarded up. The number of street furniture items along Pitt Street was the lowest of all three case studies. Furthermore, there was no consistent theme of lighting or furniture along the corridor, with different benches, trash receptacles and street lighting in each individual segment. On the other hand, there were a number of outdoor dining options along the street and within the courtyards to the sides of buildings, with a number of new restaurant options advertised to be open in the near future (Figure 24).

Figure 23: The Seaway Building, an 8-storey modernist structure at the corner of Pitt Street and Second Street, dwarfs adjacent buildings along the downtown main street.

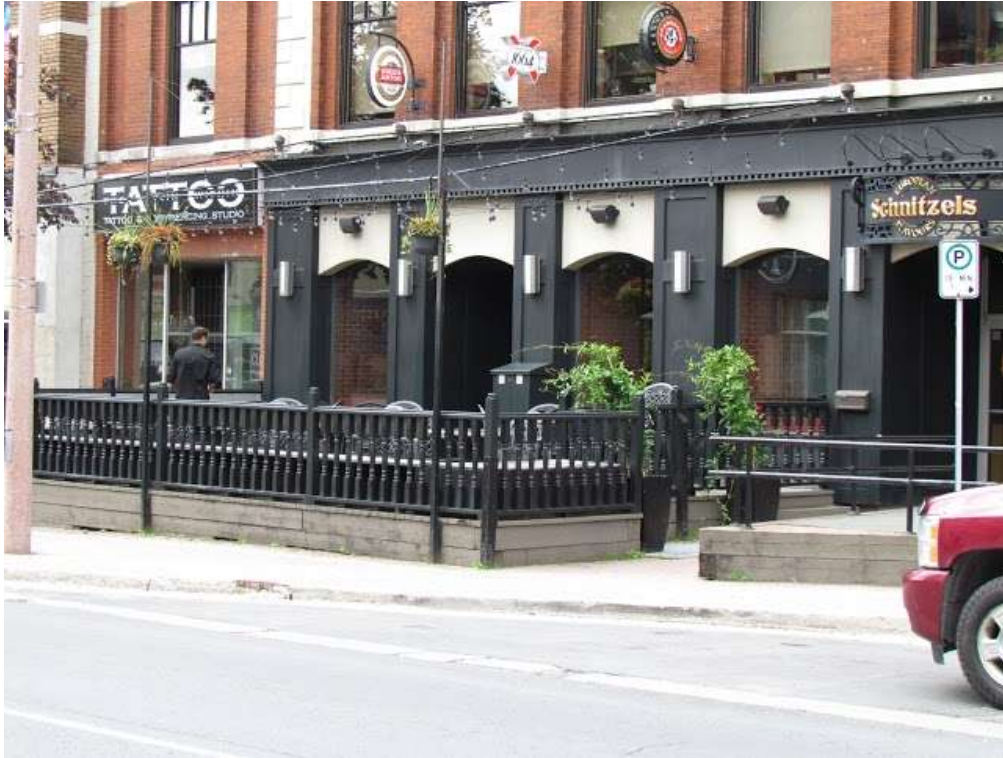
Figure 24: Restaurants take advantage of wider sidewalks for seasonal patio uses on Pitt Street.

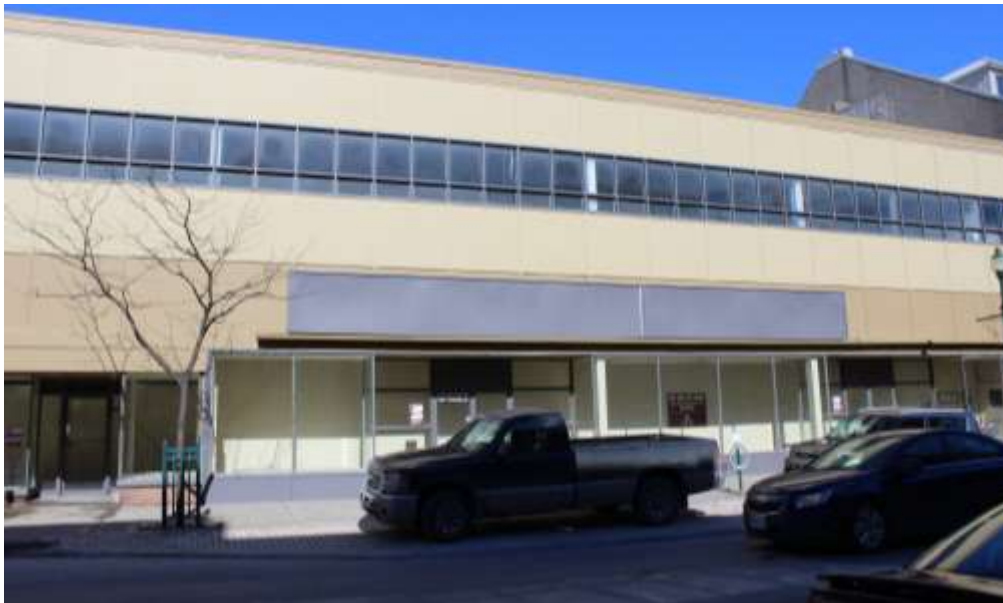
As previously explained, Brockville's King Street had a relatively consistent street wall with breaks occurring almost exclusively at street intersections. Although window coverage was high, the proportion of active uses along the corridor was low due to a high number of vacant building storefronts.

Figure 26: One of many vacant storefronts along King Street.

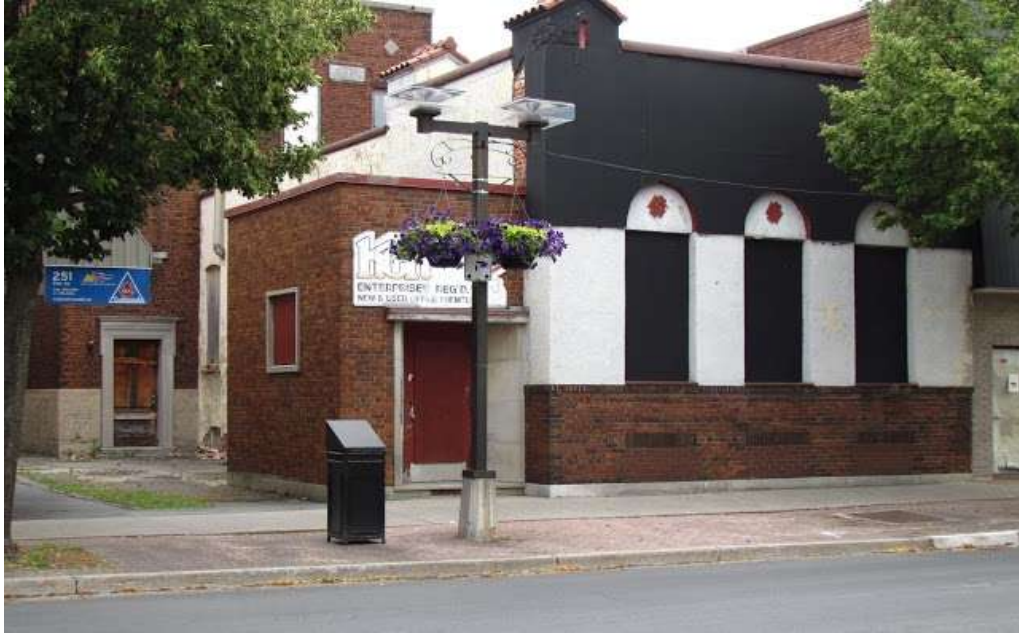
Pitt Street in Cornwall wall was penetrated by a number of vacant lots, parking access alleyways and courtyards. Scores for active use were the lowest of all three case studies due to the high number of building vacancies. Furthermore, many storefronts had few or no street-fronting windows.

Figure 27: Underutilized alleyway and street frontage along Pitt Street in Cornwall.

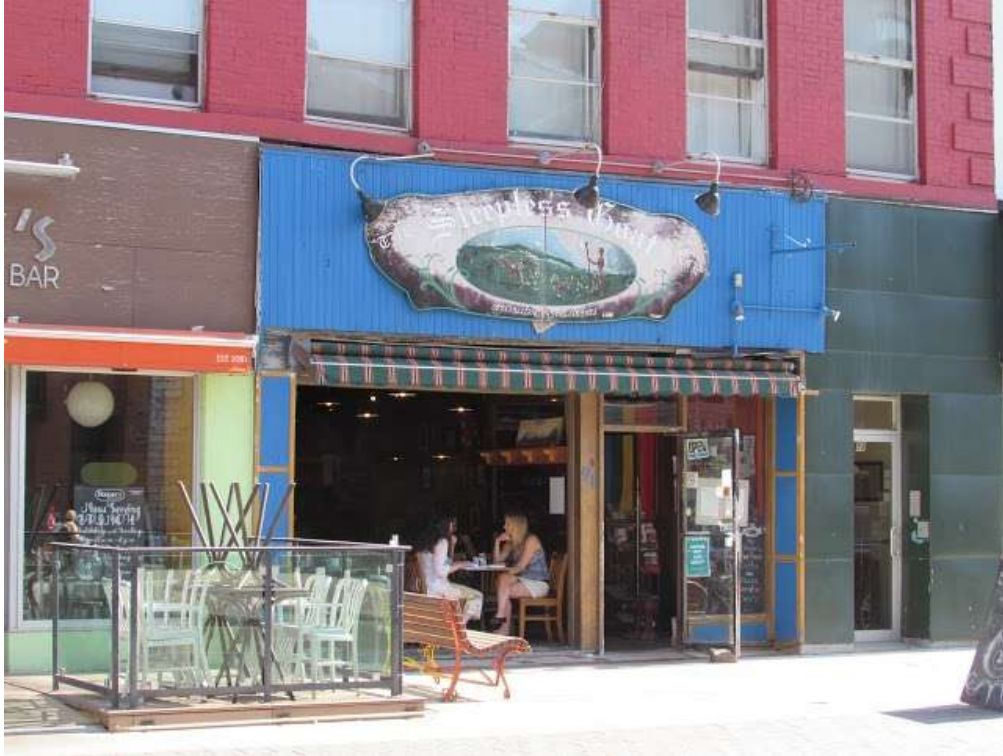
Figure 28: The Sleepless Goat in Kingston does not have a patio but uses a walk-through storefront concept to connect with the sidewalk.

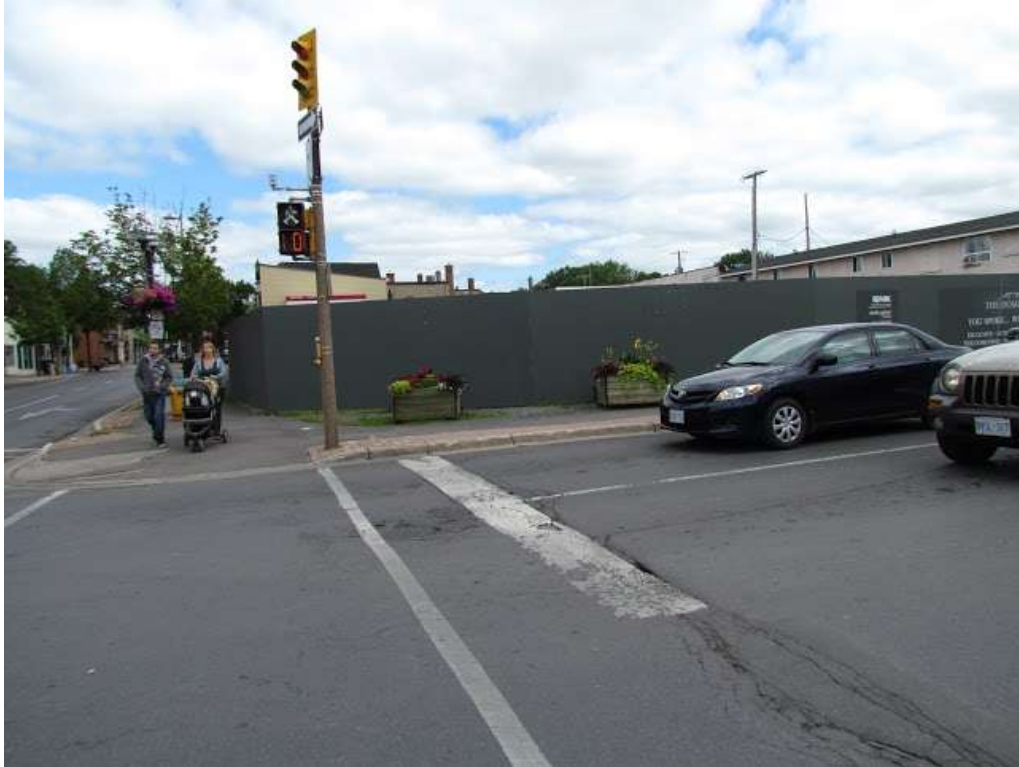
Figure 35: Empty corner lot on the corner of Pitt Street and Second Street in Cornwall.

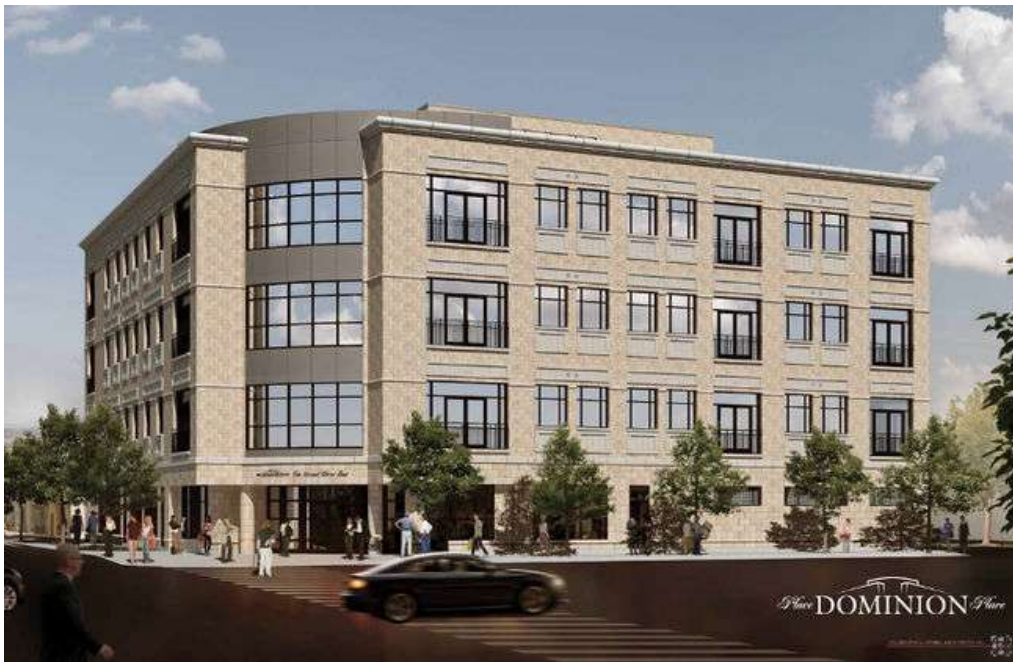
Figure 36: The Dominion, Cornwall – a proposed 4-storey mixed-use infill project at the corner of Pitt Street and Second Street. SOURCE: Bourgon Construction.

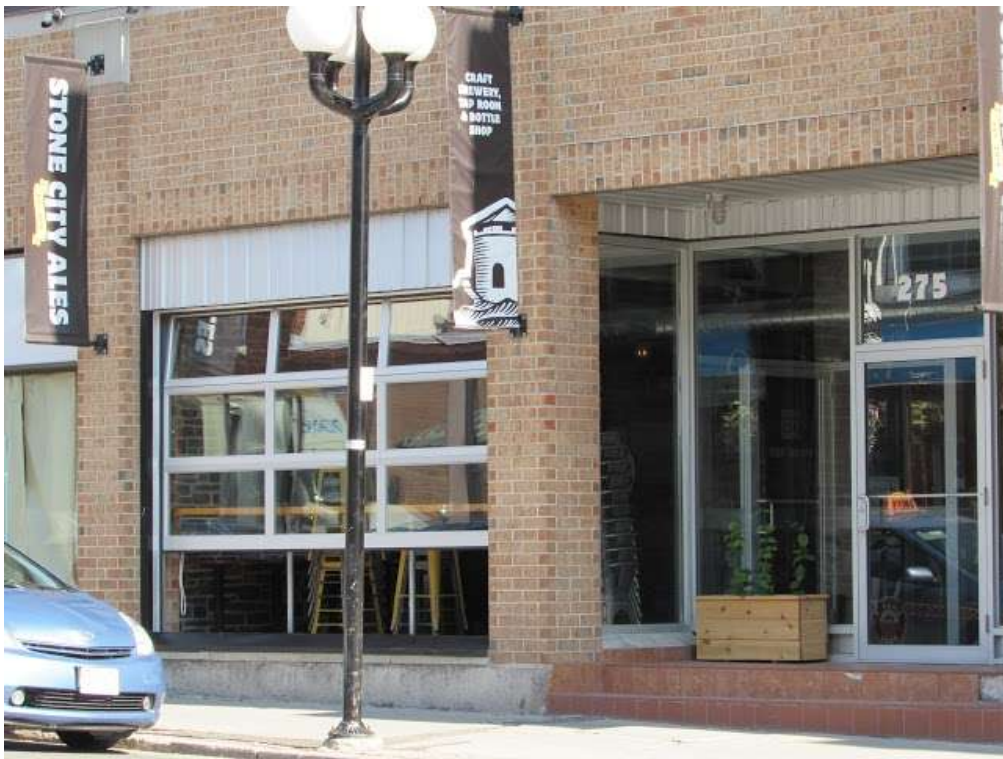
Figure 38: Kingston's narrow sidewalks limit patio space. This brewery on Princess Street upgraded its storefront to include a garage door that can be opened to seasonally create a mock patio.

Both King Street and Pitt Street have relatively narrow pedestrian clearways along their equally narrow sidewalks and there is little opportunity to set up functional patio space. Utilizing sidewalk bump-outs and alleyways for outdoor dining is recommended in the Brockville and Cornwall case studies in order to increase the proportion of active use along the corridors. Some Cornwall restaurant owners are adopting this principle already, with a new restaurant in a re-purposed building downtown utilizing an old parking lot entrance space for patio dining (Figure 37). When there is insufficient space for a proper patio, restaurant and drinking establishments are encouraged to create an open air environment for diners and to enhance the pedestrian's perception of transparency while travelling along the corridor (Figure 38).

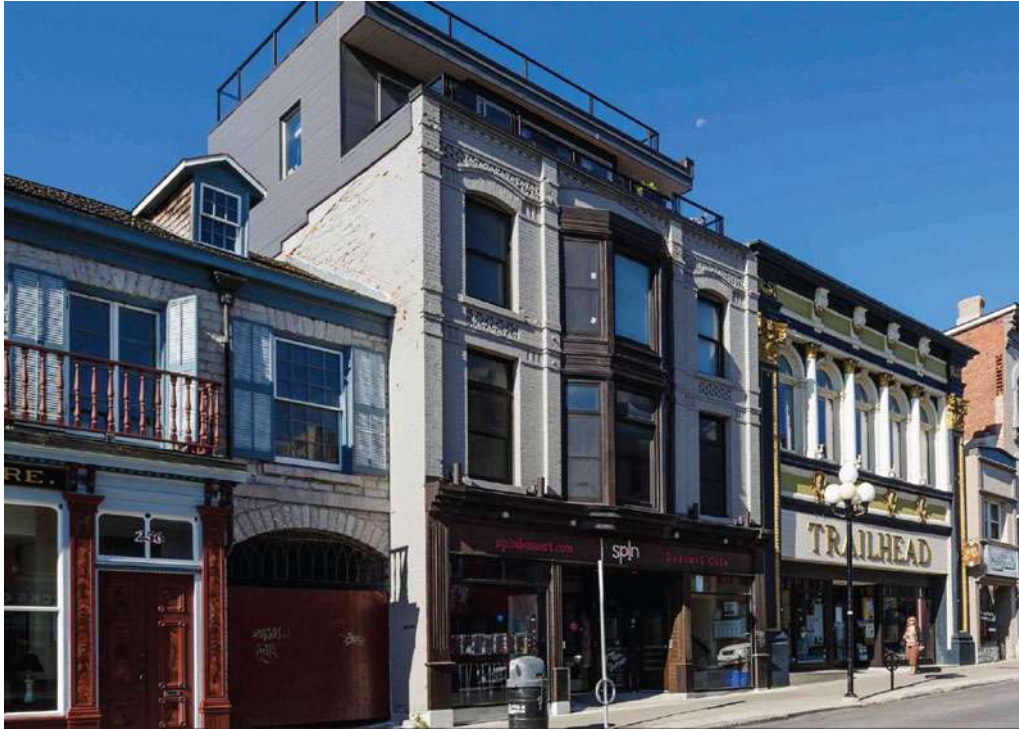
Figure 39: Infill development along Princess Street is modern in style but is set back from the street and creates an interesting building articulation along the streetscape.

Complexity, imageability and human scale can all be addressed by encouraging the strategic use of colour, building materials and building articulation. While infill development and additions to existing buildings should respect the height and setback requirements of the neighbourhood, consideration should also be given to building form and its relative appearance along the streetscape. Stepbacks, use of colour and integration of materials that respect and even showcase the heritage attributes along the street should be encouraged.

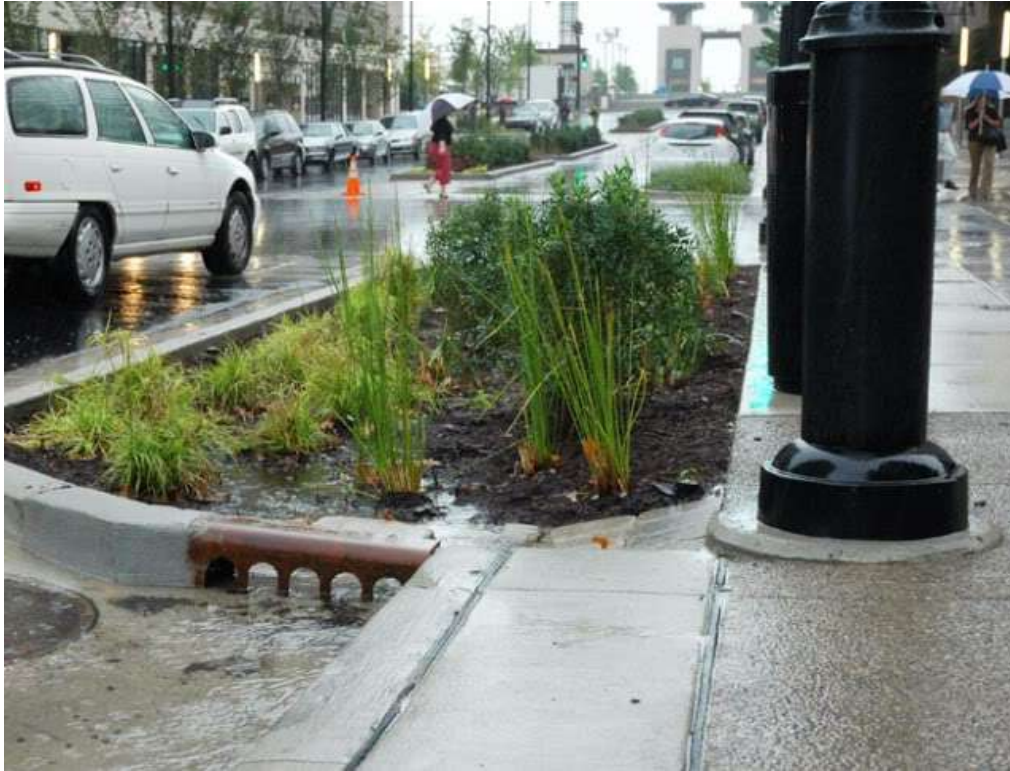
Figure 41: Traffic-calming curb bump-out in Pittsburg doubles as an enhanced stormwater catchment planter. Source: <http://www.project15206.org/>

It is recommended that street furniture and lighting be replaced along Pitt Street with consistent and enhanced upgrades. Benches should be located in illuminated areas and close to street trees in order to provide adequate light and shade to users at various times of day. The use of innovative planting boxes may also provide opportunity to integrate seating and stormwater management capacity into their design (Figure 41). Planting and street furnishing placement should also aim to create a barrier between the pedestrian and vehicular realm, promoting the pedestrian's perception of safety while walking down the street (Figure 42).

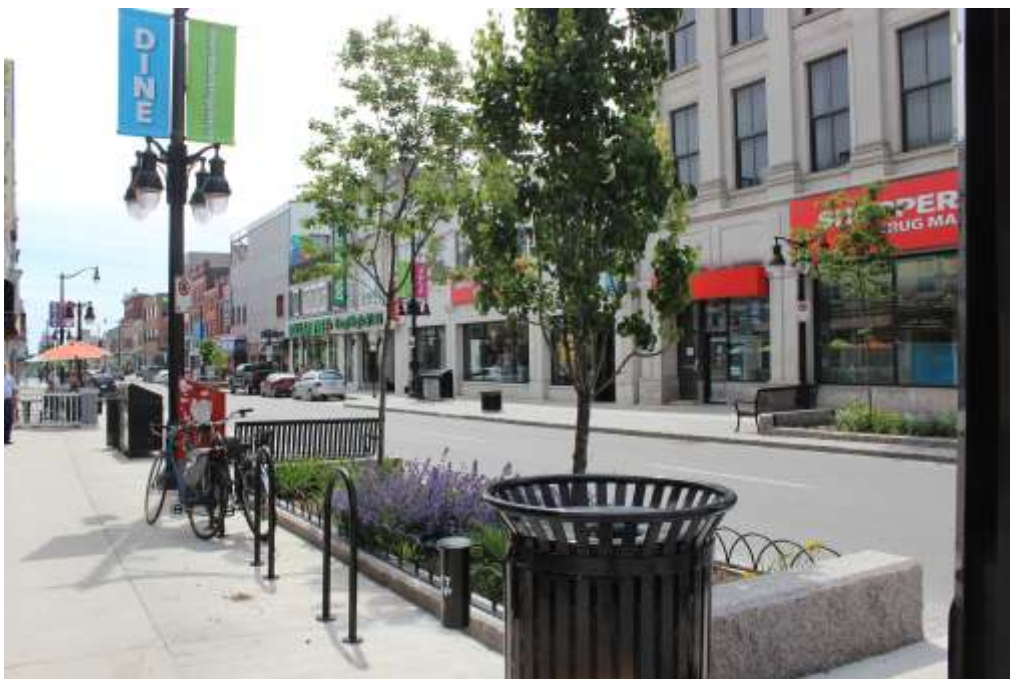
Figure 42: Kingston's street furniture and plantings are a good example of integrating natural elements within the hardscape of a narrow ROW.
